Technical Report

Te Ngaru Catchment Flood Hazard Study

SEPTEMBER 2005
AM 05/16
HBRC PLAN NUMBER 3794

Prepared by:
Craig Goodier, Senior Design Engineer

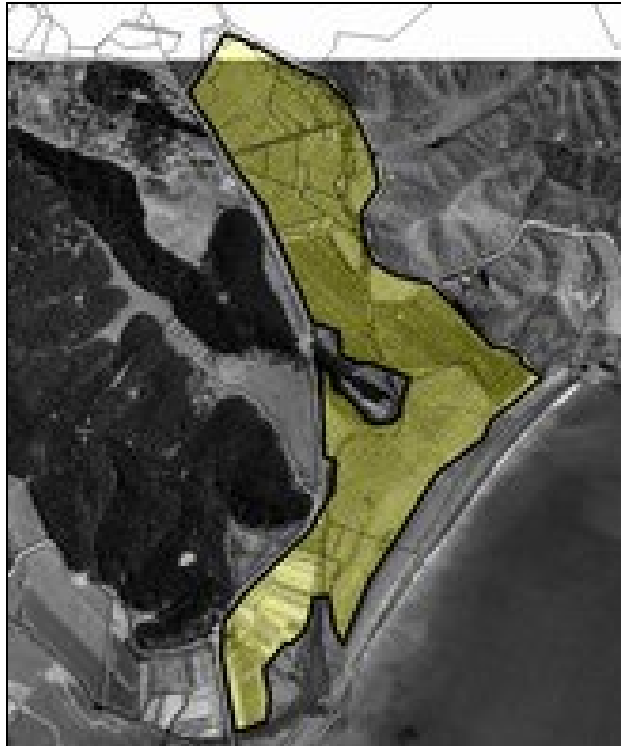
Figure 3: Te Ngaru Flood Control Scheme Rateable Area

The scheme assets that are maintained are the 3 km section of stream from the coast up to Tangoio Settlement Road. The rating area for the scheme is shown in Figure 3

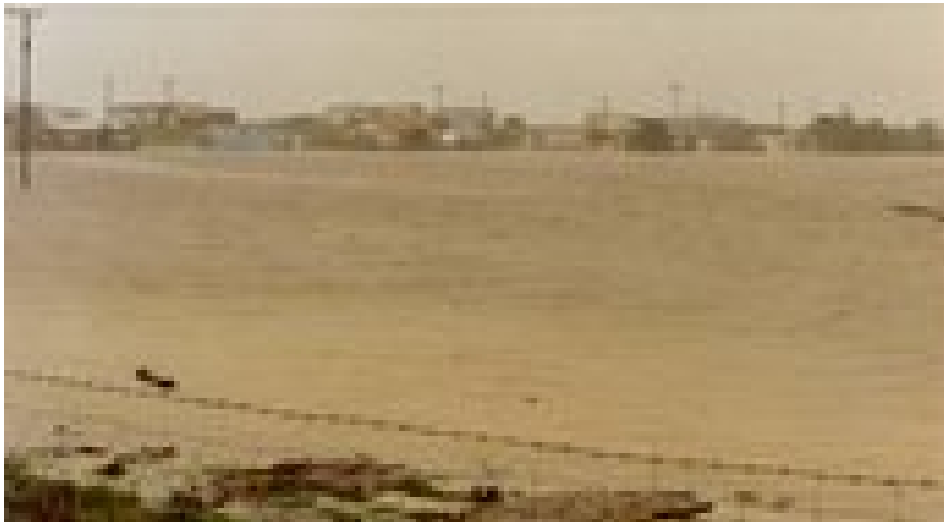
Figure 4: March 1988 – Cyclone Bola, Te Ngaru Stream Floodplain

The Te Ngaru Catchment had received about 310 mm of rain for the month of February 1988, resulting in a wet catchment. Over the 6 days from March 5 to 11, 1988, the Te Ngaru received another 805 mm. On March 8, there was 202 mm of rain, followed by another 223 mm on March 9, then followed by 188 mm on March 10. The floodwaters can be seen in Figure 4, while the silt deposits can be seen in Figure 5 and Figure 6.

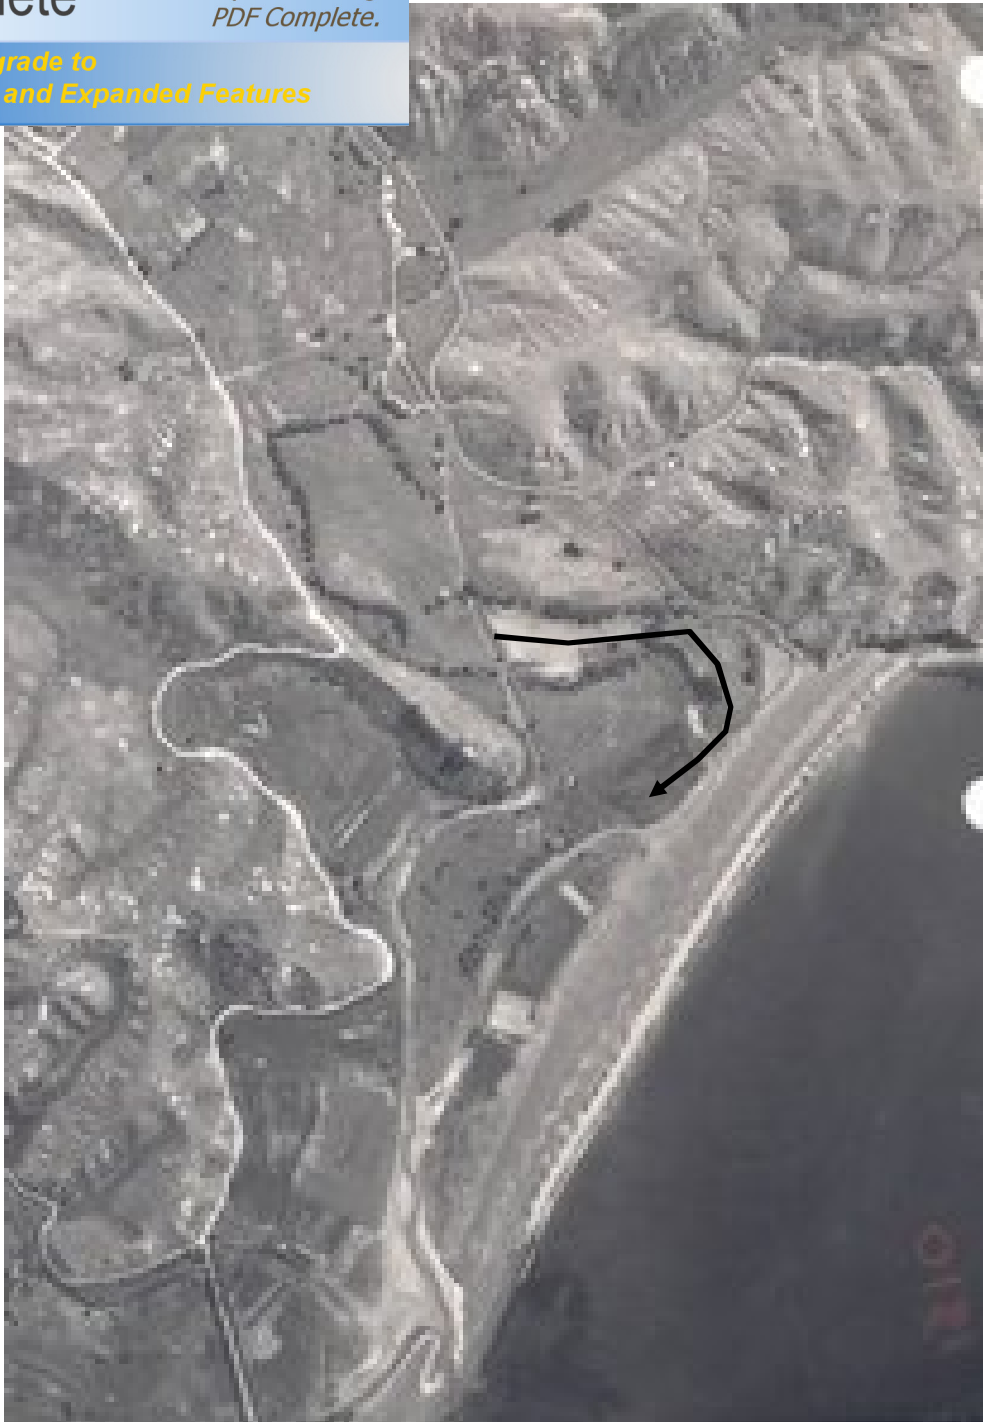
Figure 7: Air photo March 1934 (arrow showing likely flow path through treed area)

The following set of air photos is from HBRC archives, showing the change to the lower floodplain over the years. The trees in the 1934 photo show the original flow path that the out of channel flow may have taken during a flood. The subsequent photos show how the area has gradually been developed for farming.

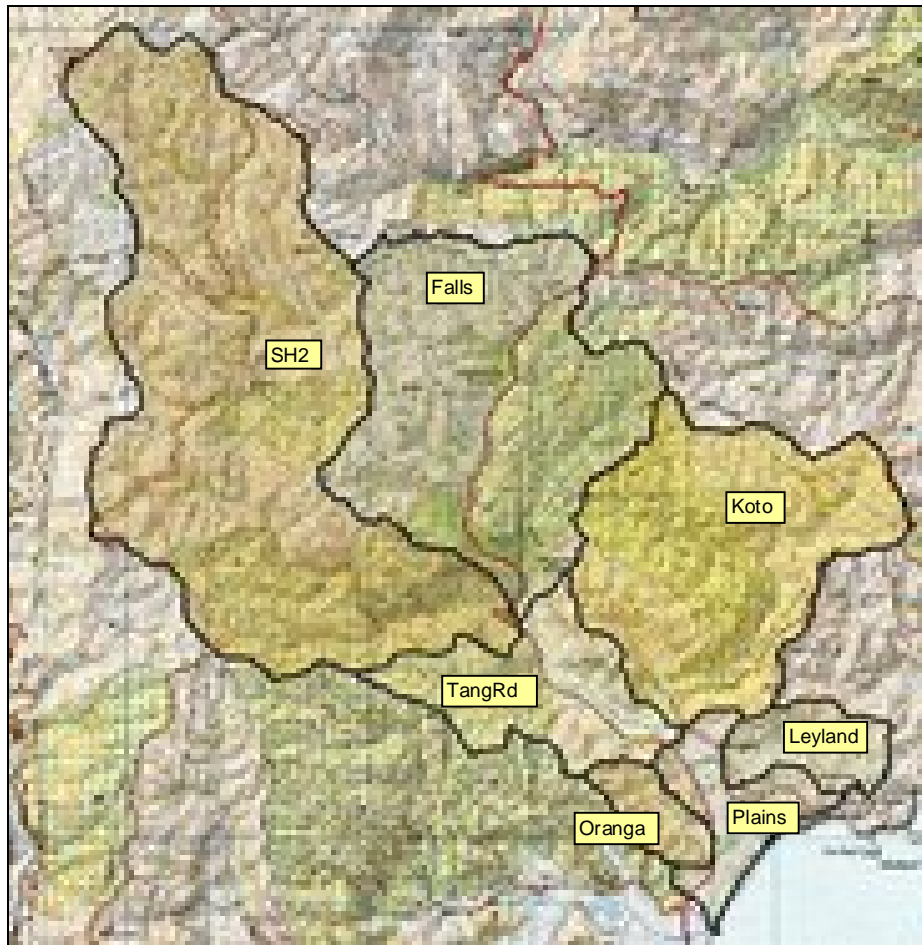
Figure 12: Catchment Delineation for Hydrologic Model (subcatchment name shown)

to 7 separate sub-catchments for the hydrologic model.

The model parameters for each subcatchment were assigned based on physical conditions, as well as knowledge from modelling similar catchments in other parts of Hawke's Bay.

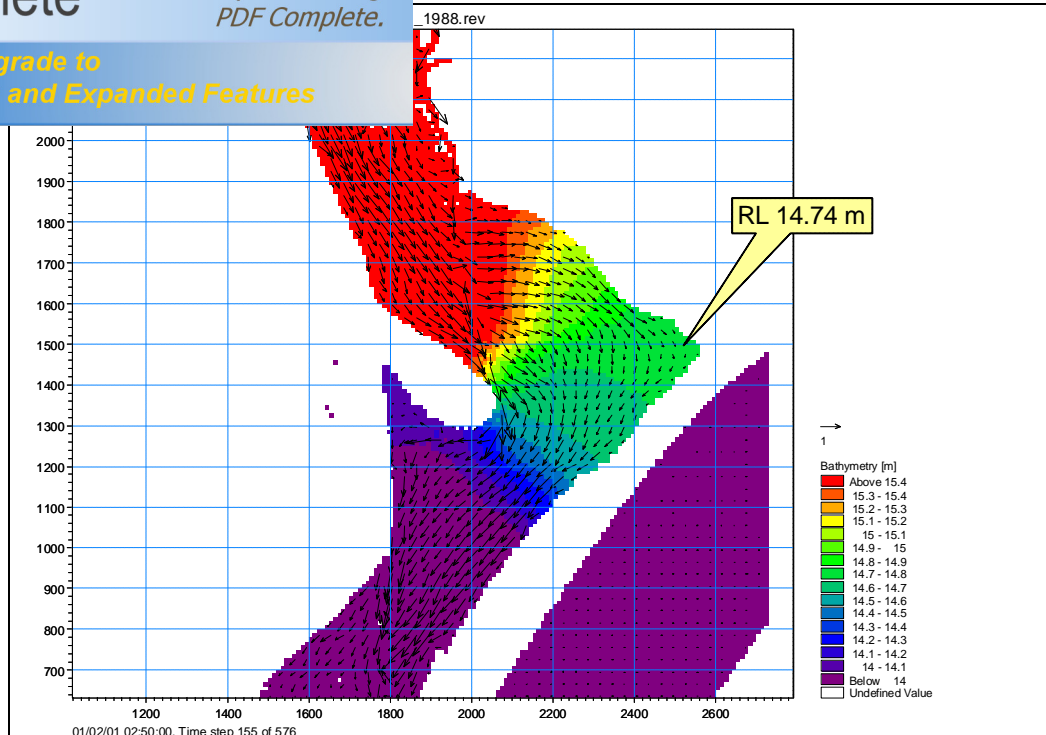
Figure 14: 2D Hydrodynamic Model Results for Bola (March 88) – Water Levels and Velocity Vectors

The hydrodynamic model was run with the hydrograph generated from the hydrologic model for the March 1988 storm (Cyclone Bola). The results from the model show the maximum water level at same location of above photos to be RL 14.74 m.

The above results show that the model is able to predict (within a level of accuracy) the water levels on the floodplain, based on a given rainfall event.

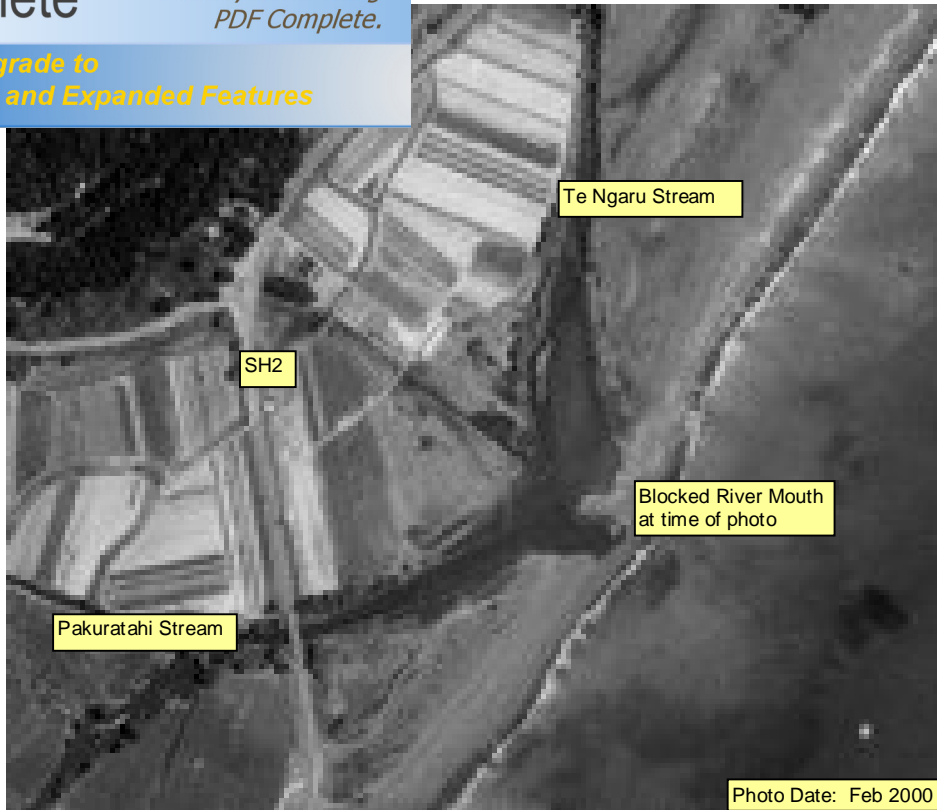
Figure 15: Te Ngaru River Mouth

The mouth of the Te Ngaru stream is shared with the Pakuratahi Stream. The combined catchment area is about 87.5 km².

There have been many occurrences of the river mouth blocking from heavy seas depositing shingle across the mouth. This is common for these types of river mouths, with the Esk, Ngaruroro, Tukituki, and several others behaving in similar fashion. The Te Ngaru has a scheme in place to mechanically open the river mouth in the event it is blocked by shingle. Over the period from 2001 to 2005, the Te Ngaru was mechanically opened 40 times. Despite the procedures being in place, there is considerable risk that a blocked river mouth may not be able to be opened prior to a large rainfall event occurring. In the past, the weather patterns that produce the extreme rainfall events also cause large ocean swells, which are the cause of the shingle depositions that close the river mouth.

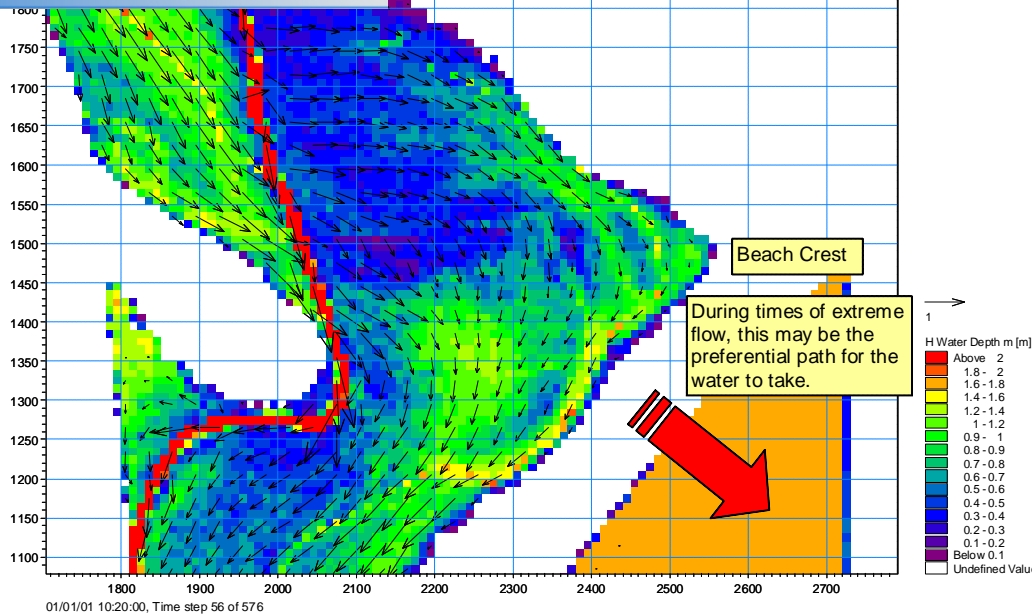
Figure 17: Te Ngaru Floodplain showing velocity vectors

The velocity vectors from the hydrodynamic model show the path the water must take in order to turn the corner before the beach crest. In order to turn this corner, there is a significant amount of energy from the momentum of the water that will be causing the beach crest to erode. At the same time, the change in direction will cause the water to slow in velocity, which in turn causes silt deposition to occur.
